Manhole Inspection Summary

Manhole # S15KK1004MH

Insp Date: **6/19/07 1:23 PM**

Location Address: **GREENSPRING AVE**

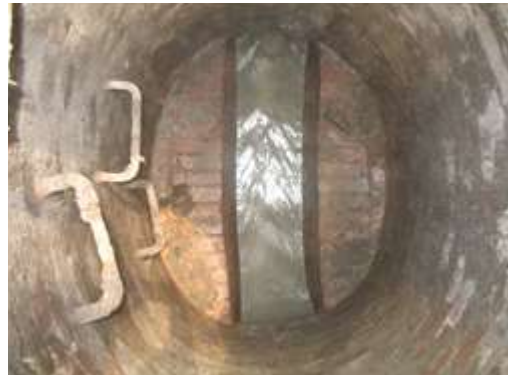
Top View

Bench ☒ Exists Material: **Brick** ☐ Parged ☒ **Debris** (not Condition related)

Surcharge ☒ **Evidence Of Surcharge** Depth: **1.5** (ft.) ☐ Active Surcharge Present

Evidence of surcharge - Bench debris.

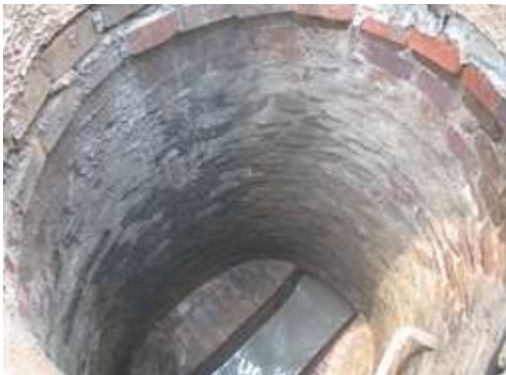
Defect

Frame Offset: **0** (in.) Condition: ☐ Sound ☐ Cracked ☒ **Leaks**

Condition: ☐ Sound ☐ Cracked ☐ Root Intrusion ☐ Loose Brick ☒ **Deteriorated**

Infiltration: ☐ None ☒ **Joint** ☐ Cracks ☐ Mortar ☐ Roots ☒ **Wall**

Infiltration: ☐ None ☐ Joint ☐ Cracks ☐ Mortar ☐ Roots ☒ **Wall**

Frame leaks. Adjustment deterioration and infiltration. Barrel infiltration.

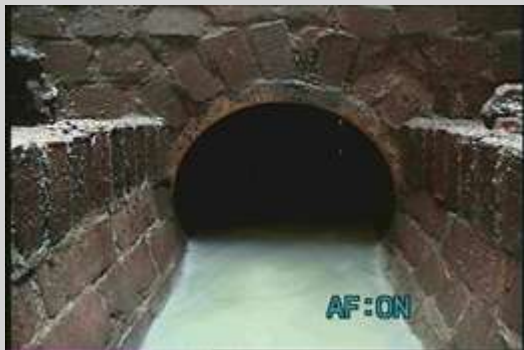
12 in. Circular Gravity Sewer Pipe Out @ 12 O'Clock

Infiltration: **Evidence** Pipe Seal Cond: **Unknown**
